20-21 October 2021, Sofia, Bulgaria

**Renovation of public cultural heritage
buildings after the Zagreb earthquake
in 2020. – example of design**

Krešimir Tarnik, Mag.ing.Aedif.

Faculty of Medicine, University of Zagreb, Dean's building.

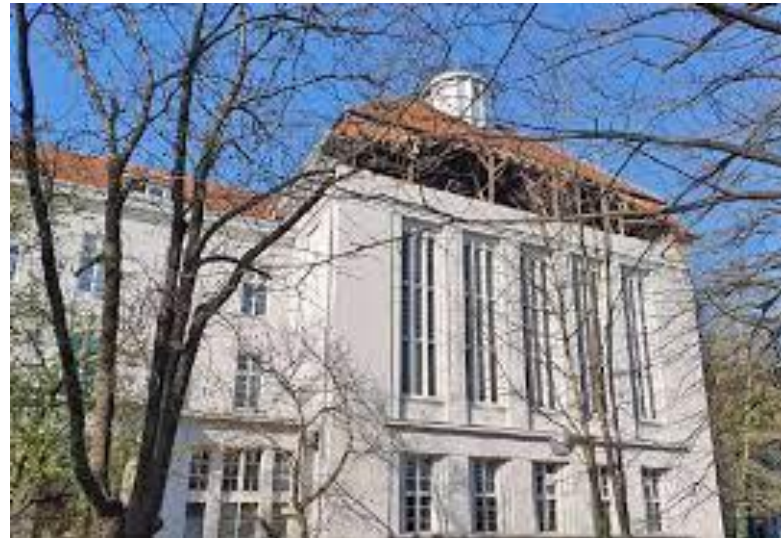
- The roof structure has suffered damage, especially to the cornices and gable above the great hall which has been completely demolished.

- The masonry pillars between the windows remained undamaged (!!!)
- Cracks in stair arches and columns
- The gable of the great hall - collapsed because it was built on a reinforced concrete beam resting upon masonry pillars without connecting to the concrete structure. The shift of the flexibly "soft" element at the top of which is the unbound mass is the cause of the catastrophic demolition of the most recognizable element of the building in question, which is also on the faculty logo.

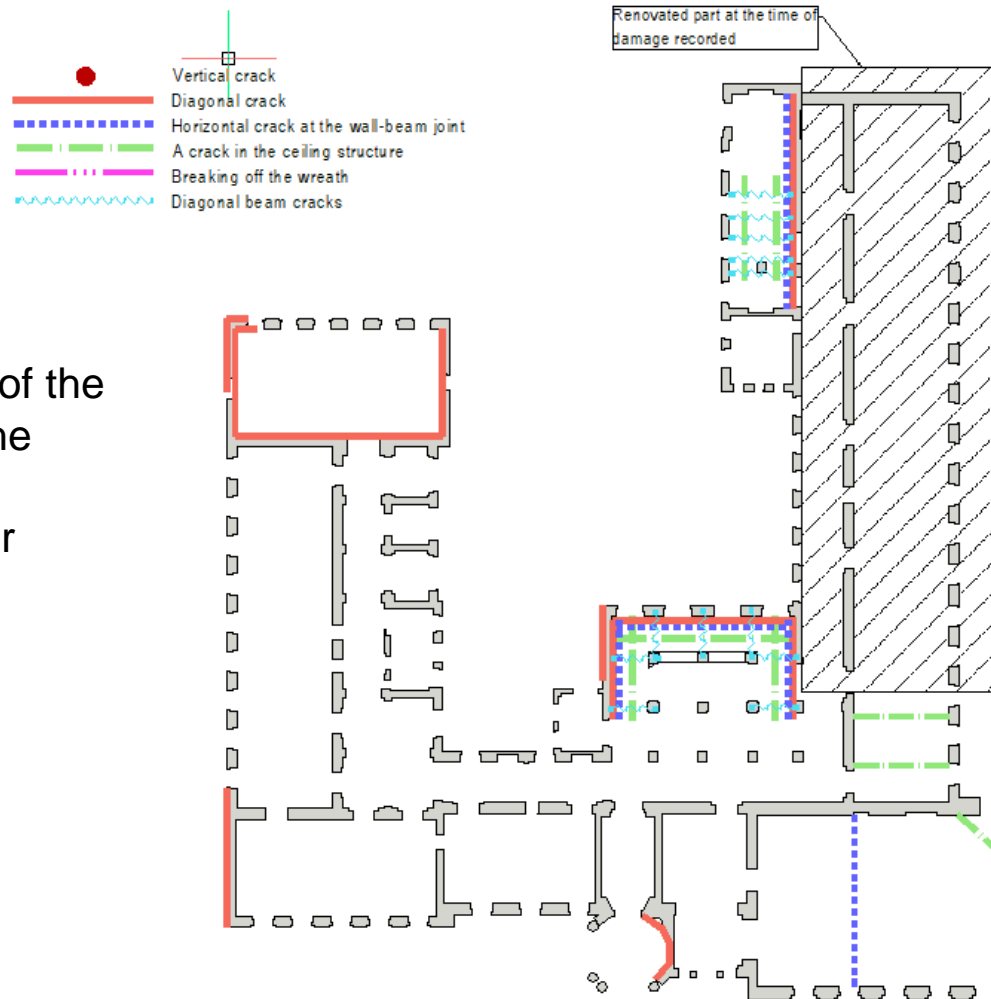
Positioning of the cracks on the floor plan – Ground floor

- Cracks formed in the zone of openings in load-bearing walls
- Cracks formed at the junction of the ceiling structure and walls
- The main load-bearing walls without openings are the most damaged because they took on the greatest shear force from the earthquake. Cracks in the load-bearing walls are formed correctly in full X-cracks from the foundation to the cornice without eruption of the load-bearing structure outside the plane of the wall.

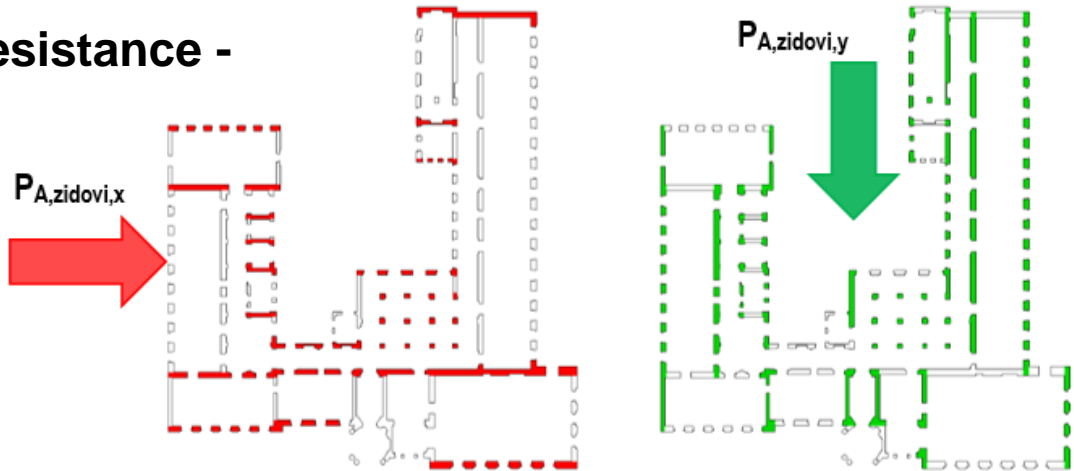
Zaključak: Seizmička otpornost postojeće građevine u x-smjeru je **2,03%** u odnosu na EC-8

Zaključak: Seizmička otpornost postojeće građevine u y-smjeru je **2,77%** u odnosu na EC-8

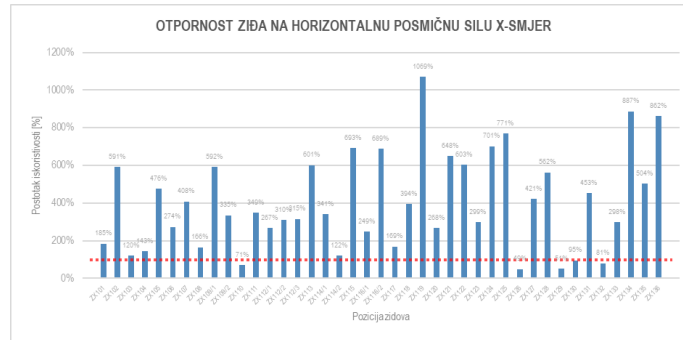
X
direction

Srednja vrijednost nosivosti - postignuti omjer u odnosu na EN 1998 iznosi - X-SMJER : **402%**

Zaključak: Seizmička otpornost postojeće građevine u x-smjeru je **6,47%** u odnosu na EC-8

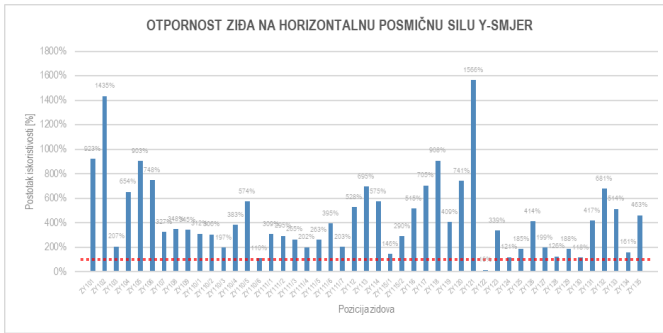
Y
direction

Srednja vrijednost nosivosti - postignuti omjer u odnosu na EN 1998 iznosi - Y-SMJER : **441%**

Zaključak: Seizmička otpornost postojeće građevine u y-smjeru je **5,90%** u odnosu na EC-8

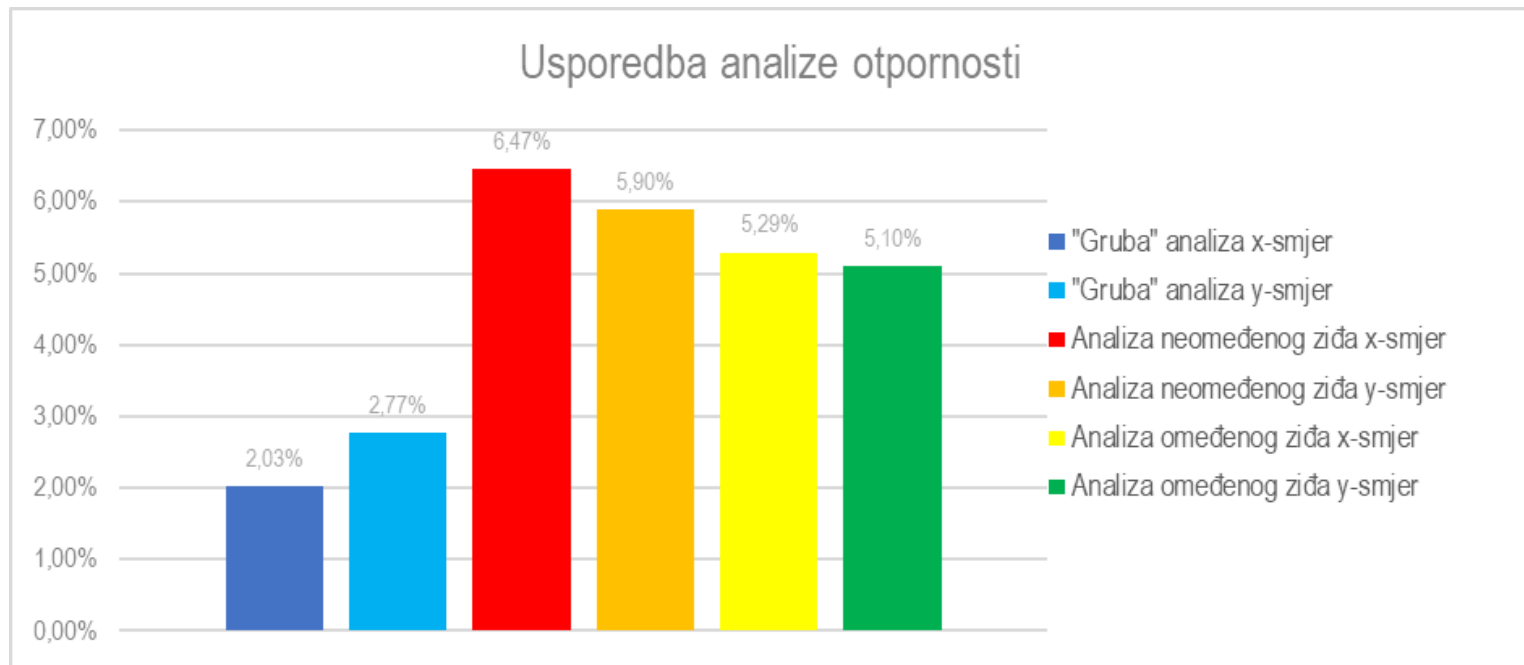
Comparative analysis of masonry resilience as a percentage of full "EC8" earthquake resistance
